Markleeville Creek Floodplain Restoration Project Alpine County, California

Initial Study/Mitigated Negative
Declaration
Volume II – Appendices A-G

February 2014

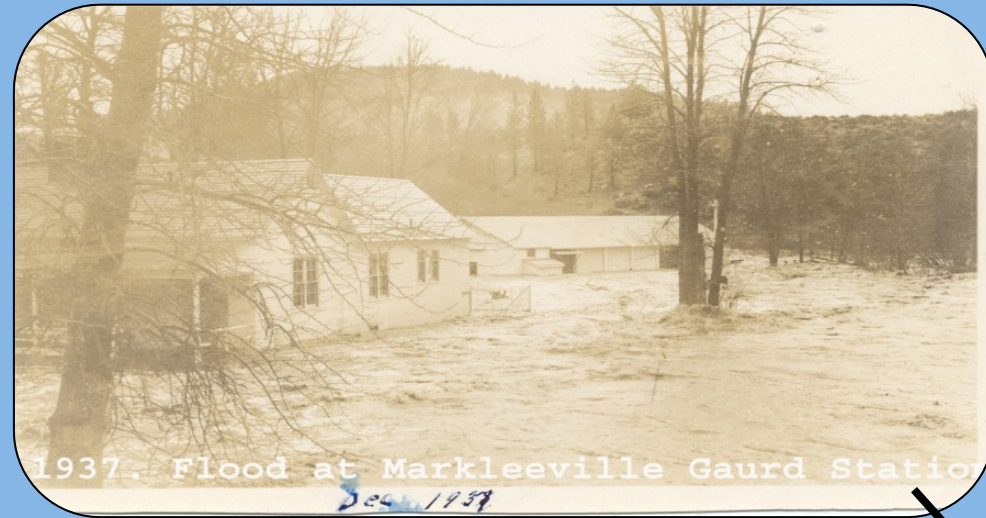
1937. Flood at Markleeville Gaurd Station

December 11, 1937

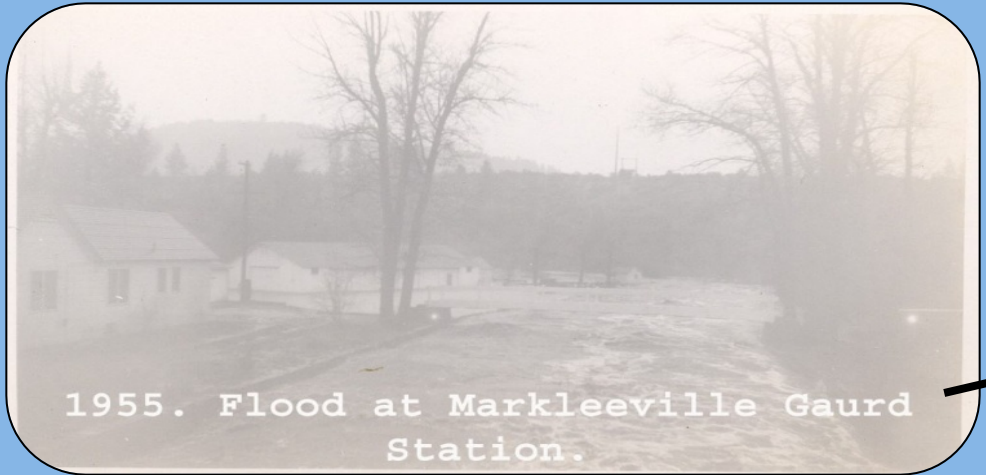
1955. Flood at Markleeville Gaurd Station.

December 23, 1955

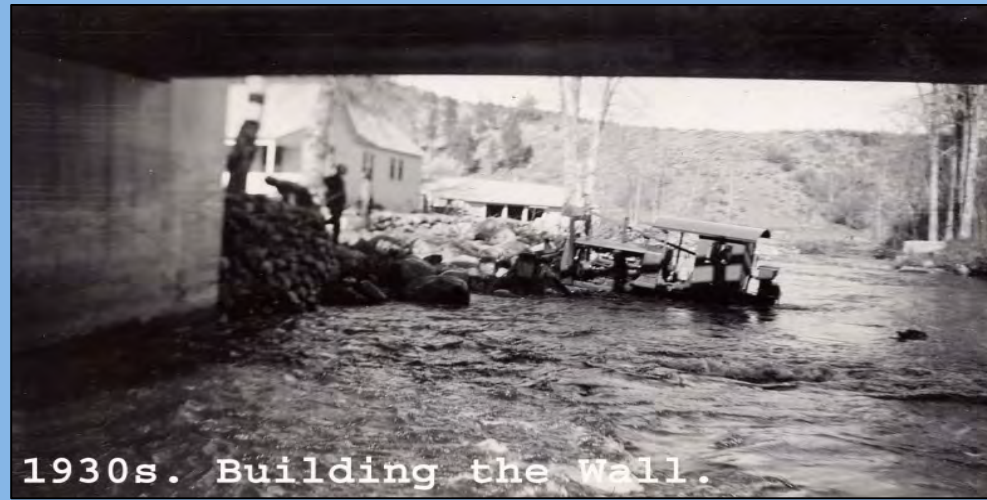
1930s. Building the Wall.

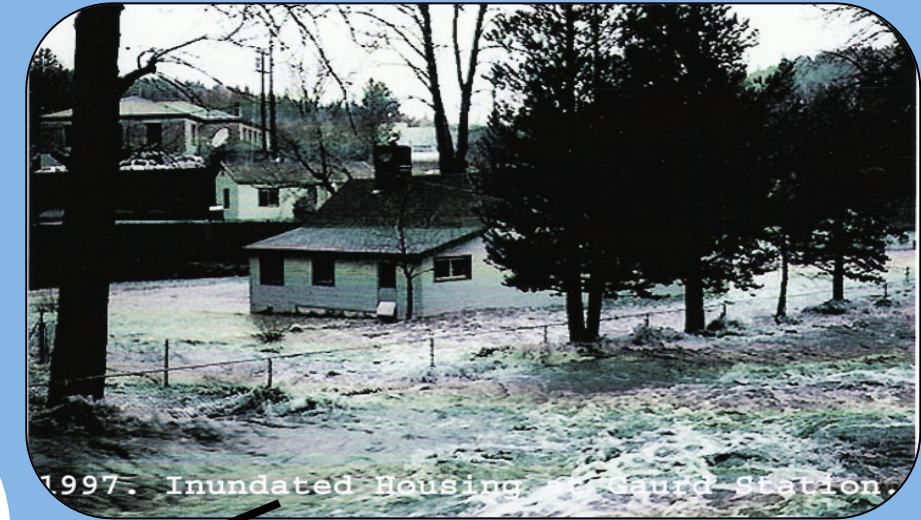
1997. Inundated Housing at Gaurd Station.

January 1-2, 1997

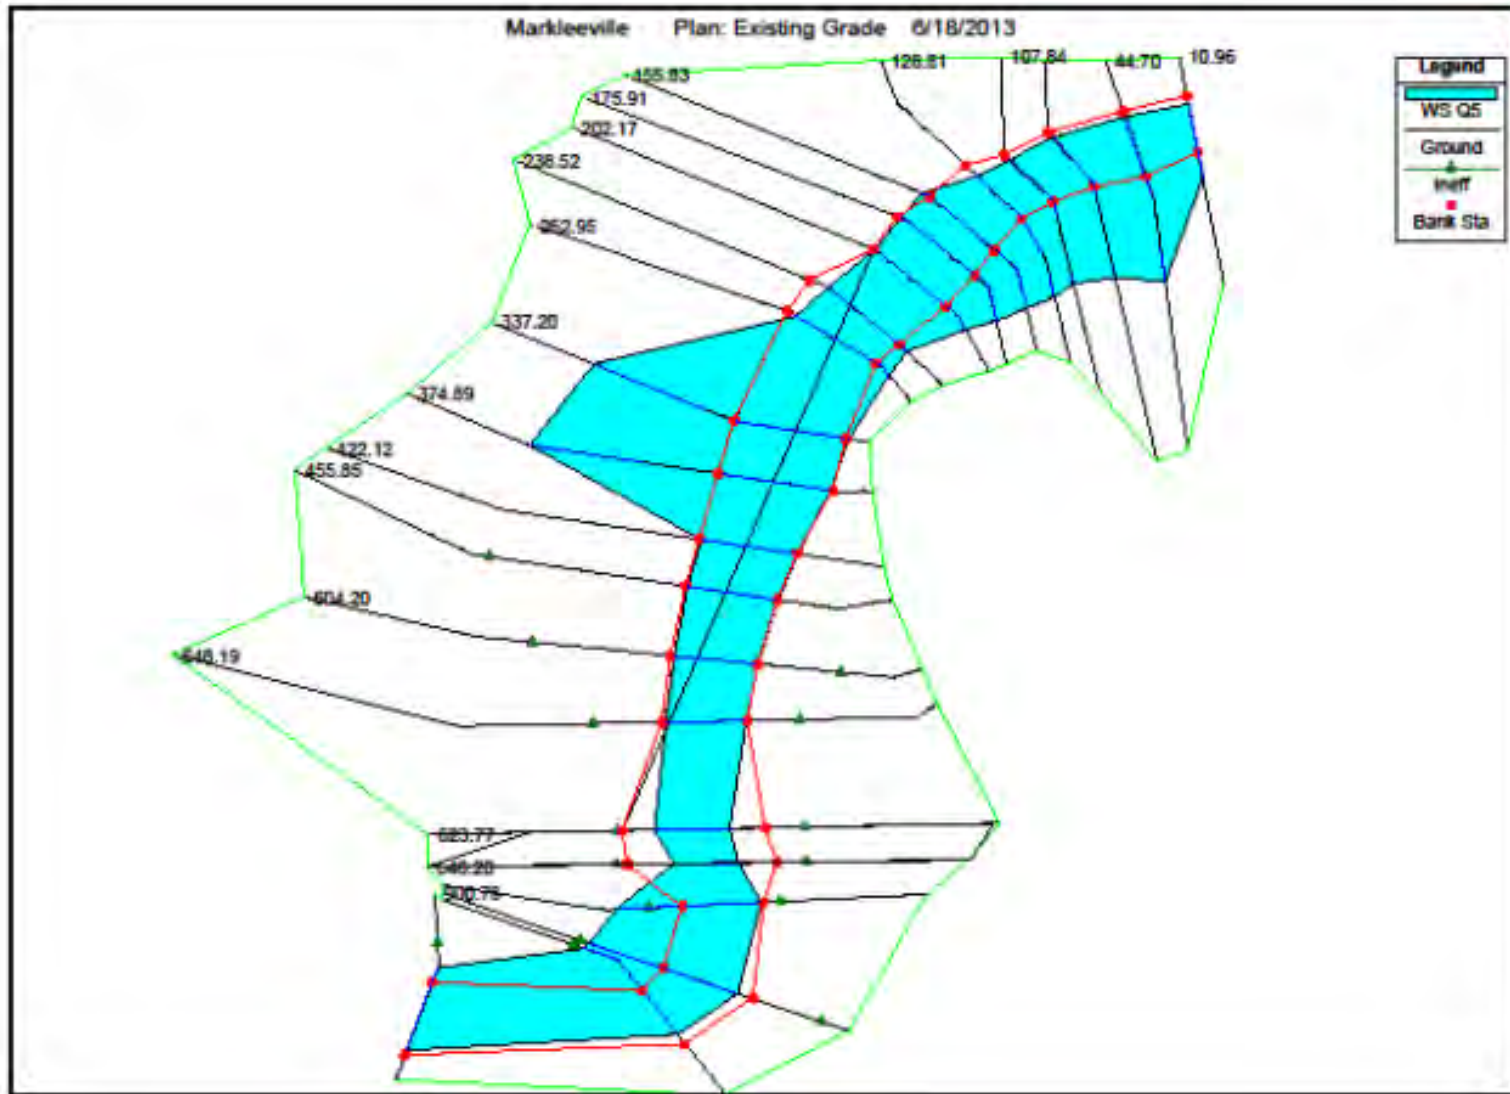
Figure A-2: Existing Condition Plan with 5-Year Water Surface

In the existing condition, flows are largely confined to Markleeville Creek due to the presence of the floodwalls. Flows do not activate the west floodplain until the 25-year event, and they do not activate the east floodplain until the 100-year event. In the 100-year event, the Highway 89 Bridge experiences pressure flow, and the water surface elevation drops nearly seven feet from the cross-section upstream of the bridge to the cross-section downstream of the bridge, resulting in relatively high velocities and shear forces downstream of the bridge. Additionally, flows are slightly confined at the downstream end of the project area by a crib wall on the west overbank, and a large boulder bar on the east overbank that formed from debris deposition in the 1997 flood. Appendix A provides existing condition output HEC-RAS.

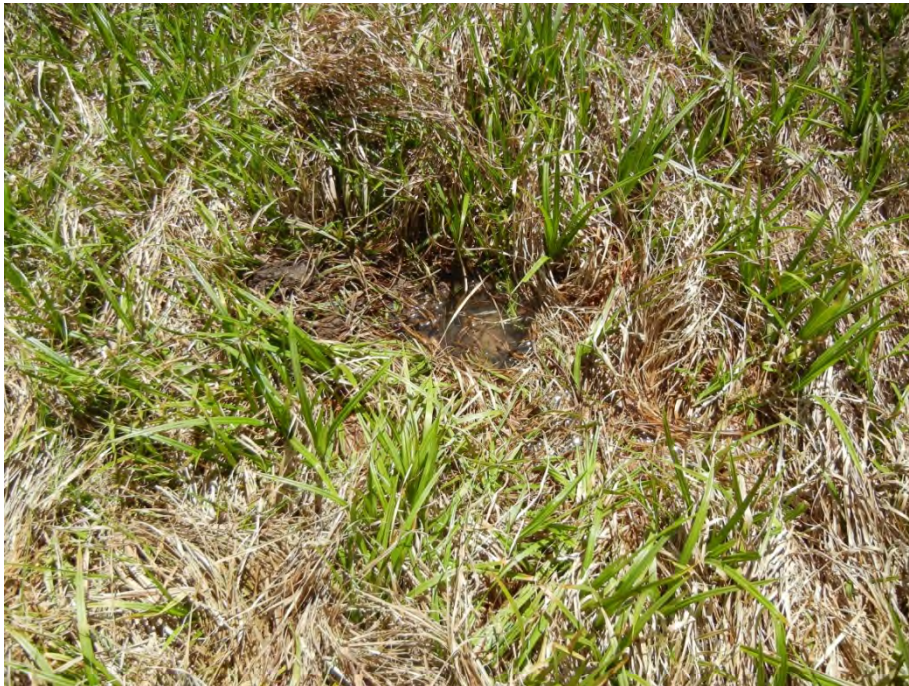
Sample Point 2 (SP2), wetland site W-1, May 15, 2012.

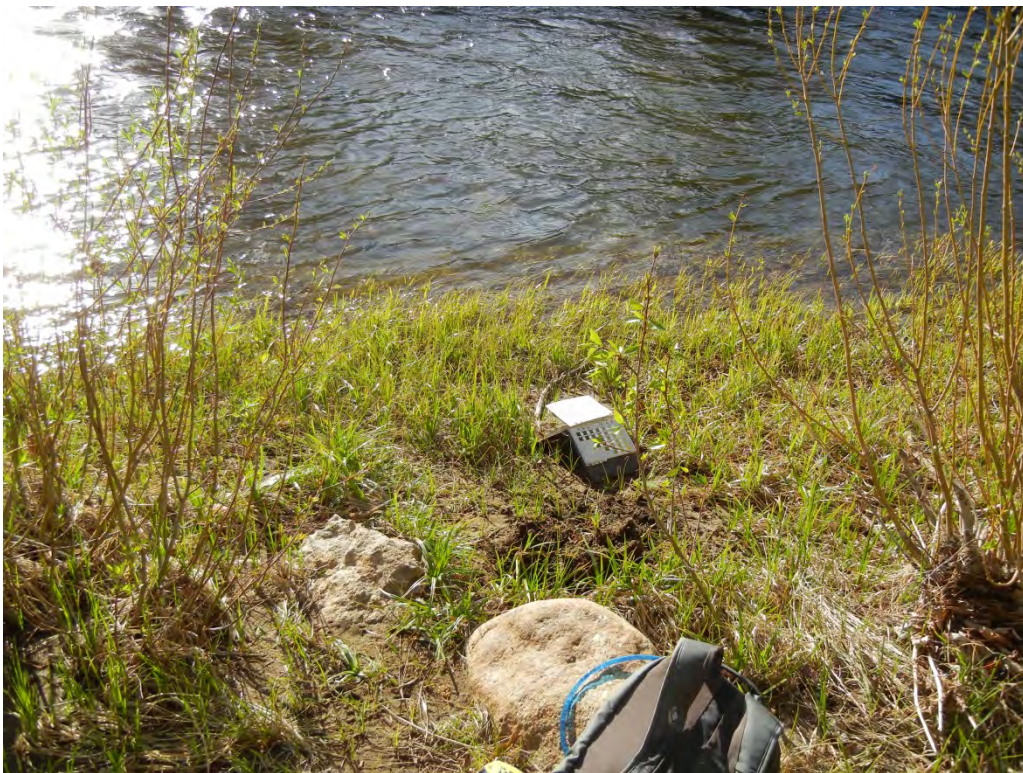
Sample Point 6 (SP6), adjacent to Markleeville Creek, east bank, wetland site, May 15, 2012.

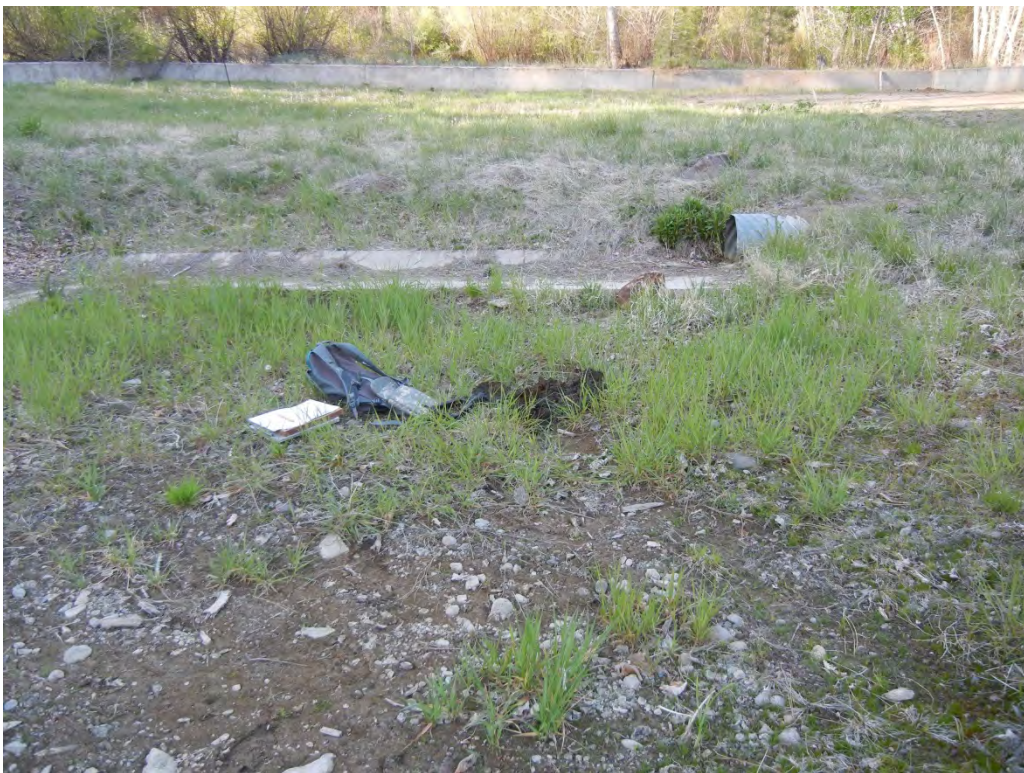
Sample Point 8 (SP8), wetland site W-2, May 15, 2012

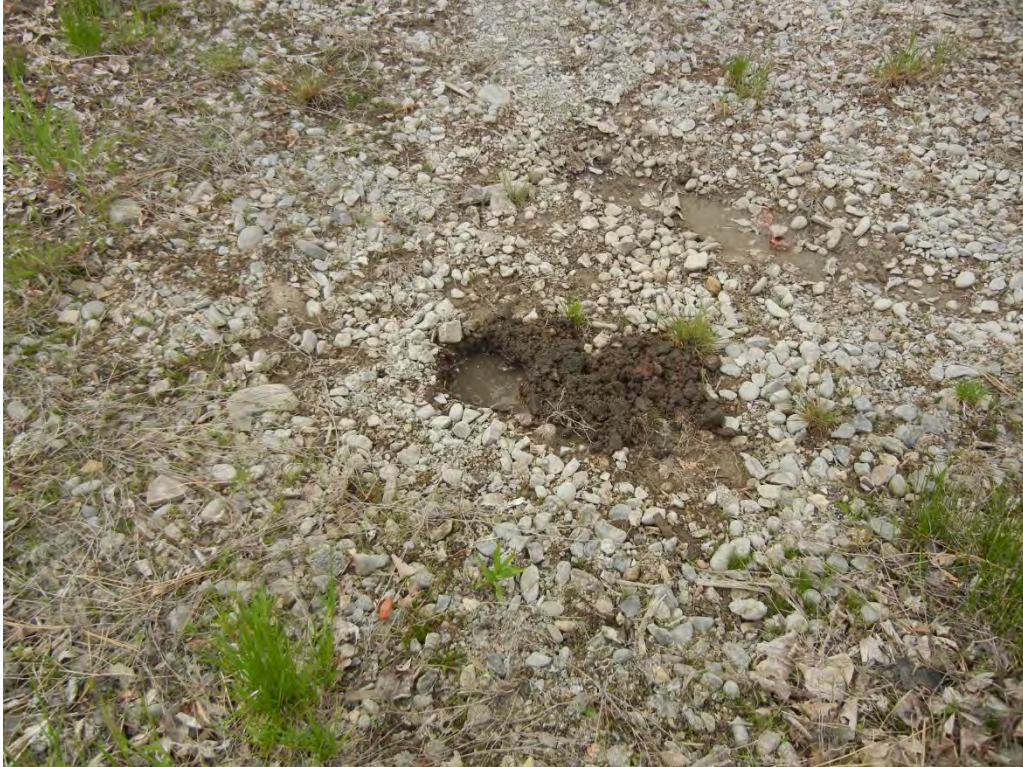
Sample Point 11 (SP11), wetland site W-2, May 15, 2012.
